REPORT NUMBER: 102271749COQ-004
ORIGINAL ISSUE DATE: December 16, 2015

PRODUCT EVALUATED: Aluminum Window Wall System
EVALUATION PROPERTY: Air Leakage, Water Penetration, Structural
Performance and Thermal Cycling

Report of Testing an Aluminum Window Wall system, following the standard test methods of AAMA 501-05 "Methods Of Test For Exterior Walls", AAMA/WDMA/CSA 101/I.S.2/A440-08 & AAMA/WDMA/CSA 101/I.S.2/A440-11 "North American Fenestration Standard/Specification for windows, doors, and skylights", and CSA A440S1-09 "Canadian Supplement to AAMA/WDMA/CSA 101/I.S.2/A440 — North American Fenestration Standard/Specification for windows, doors, and skylights"

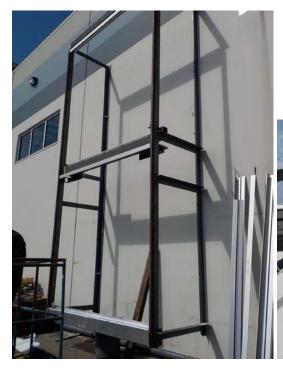
Figure 1. Installation

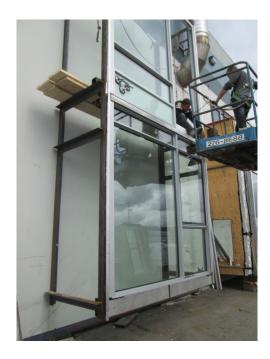
Figure 2. Installation con't

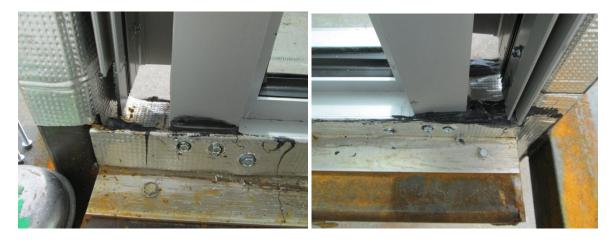
Figure 3. Installation con't

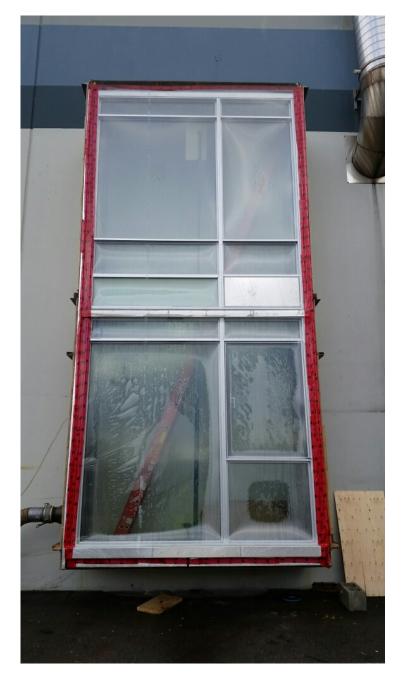
Figure 4. Completed Installation and Air Leakage Set-up

The Air Leakage test (Infiltration) was conducted in accordance with ASTM E283-04(2012), "Standard Test Method for Determining Rate of Air Leakage Through Exterior Windows, Curtain Walls, and Doors Under Specified Pressure Differences Across the Specimen". A polyethylene film was applied on the exterior of the system to separate the chamber leakage from the system leakage. A leakage value was recorded then the film was removed and another leakage value was recorded. The test was performed using a pressure differential of 75 Pa (1.56 psf).

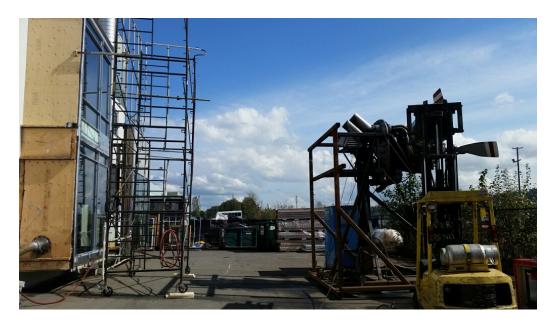
The Dynamic Water Penetration test was conducted in accordance with AAMA 501.1. The test was performed using a wind speed of 101 kph (63 mph), pressure differential equivalence of 510 Pa (10.7 psf), generated by a Pratt and Whitney R-2800 Aircraft Engine, and a water spray rate of at least 204 L/m² per hour (5.0 U.S. gal/ft² per hour). The test was run for 15 minutes, during which the pressure and water spray was continuously applied.

Figure 5. Test Set-up for Dynamic Water Penetration

During the 15-minute test period, using an approximate wind speed of 101 kph (63 mph), there was no water leakage observed. The system **met** the Dynamic Water Penetration requirements of the AAMA 501.1.

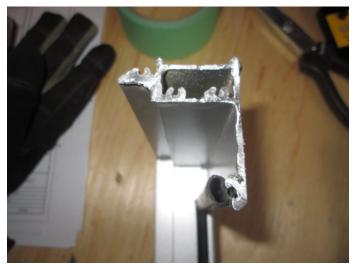
Casement Main Frame Insert Profile

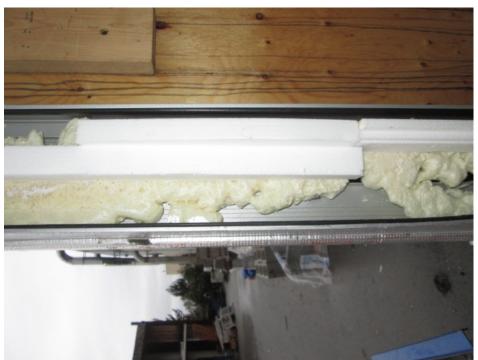
Inside Jamb Track

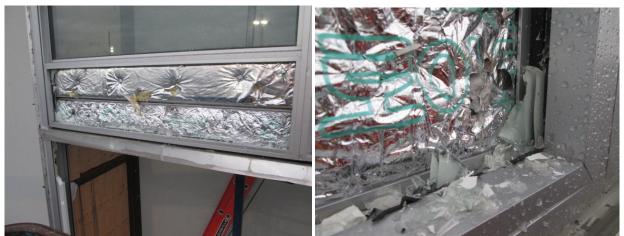
Inside the Stainless Steel Back-Pan w/ Glazed Exterior

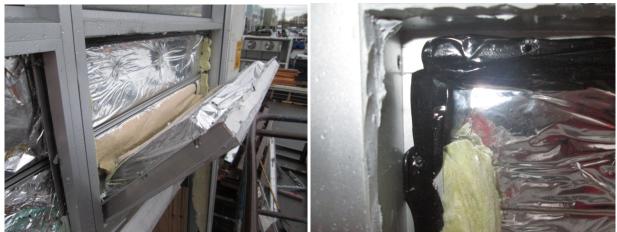
Inside Stainless Steel Back-Pan w/ Stainless Pan Exterior
